Site Inventory and Period of Significance Study

Excelsior Commons and Port of Excelsior
Excelsior, Minnesota

November 3, 2017

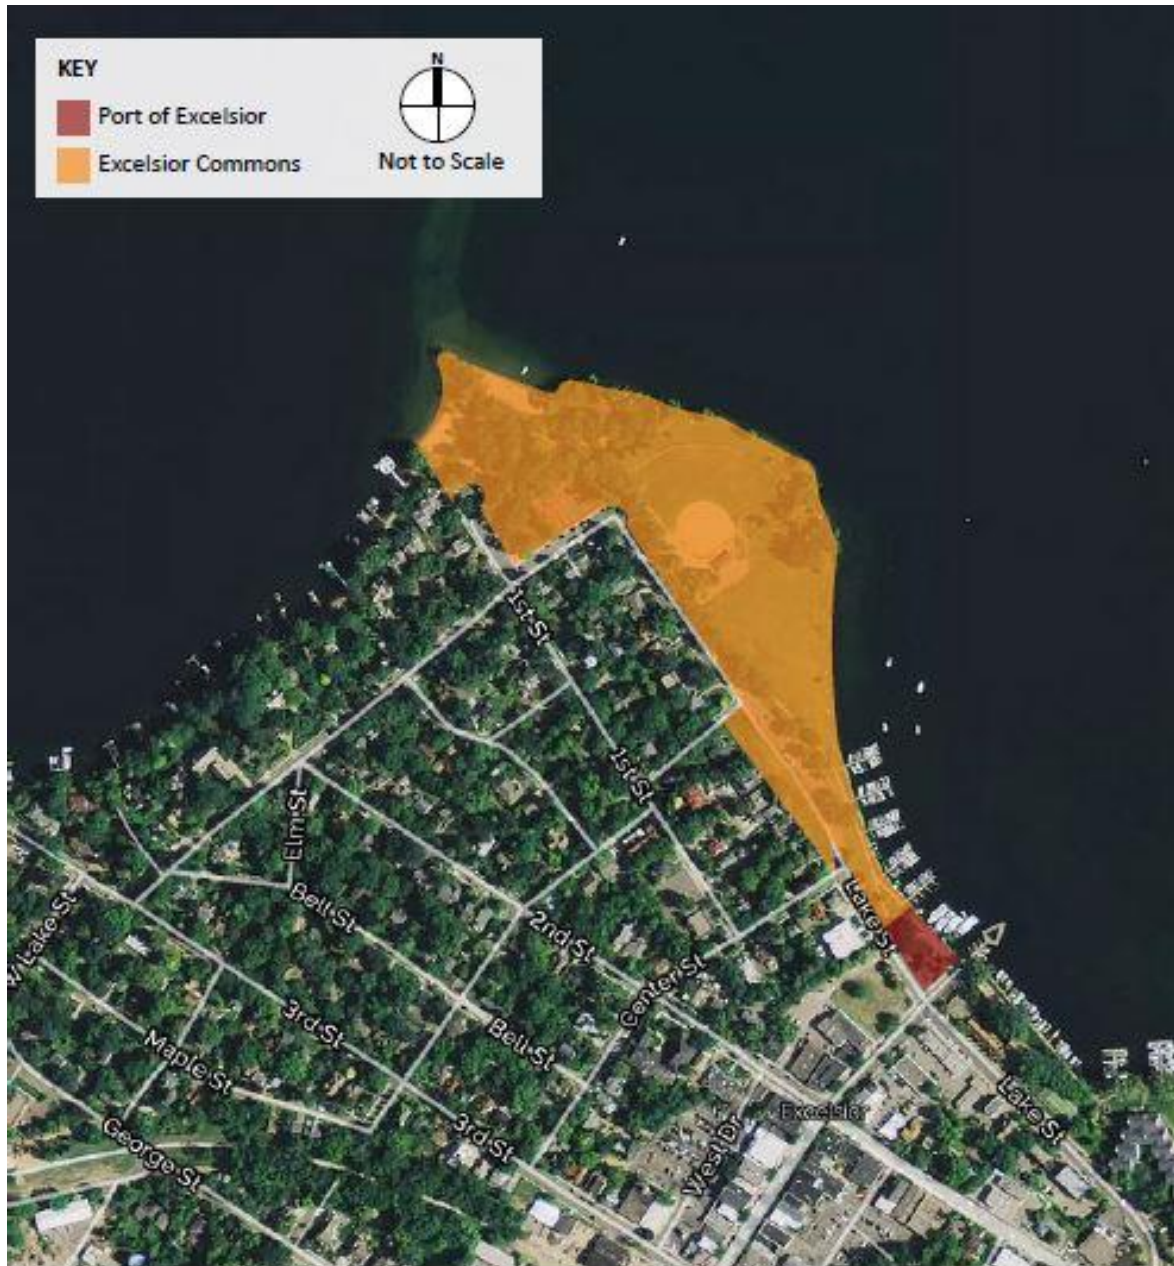
Excelsior Commons and The Port of Excelsior, 2017. Background image via Mapquest.

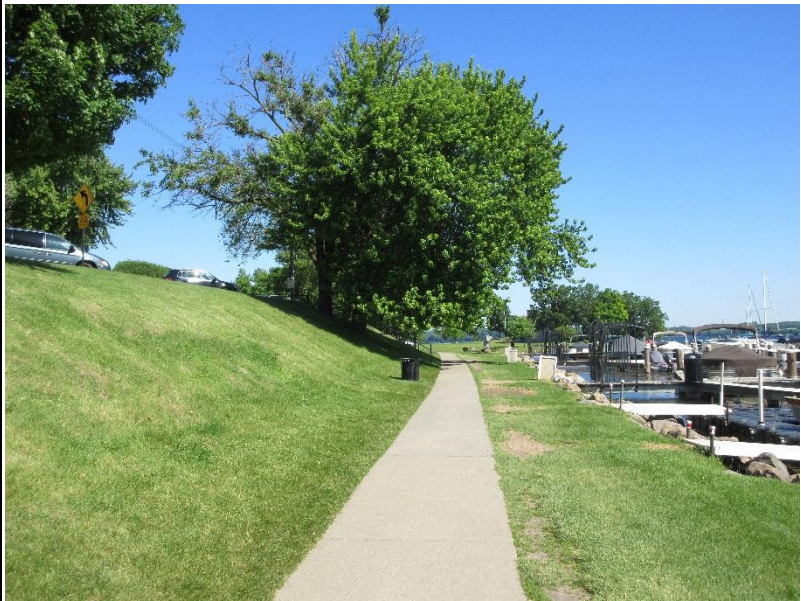
Change in Grade Along Lake Street

The change in grade down from Lake Street to the rest of the Commons is present in photographs and aerial images of the park throughout its history.

This change in grade along Lake Street **IS** a Character Defining Feature of Excelsior Commons.

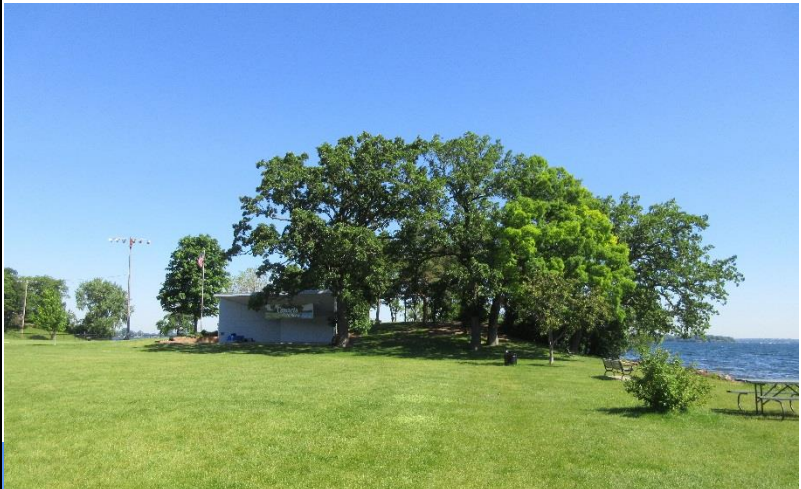
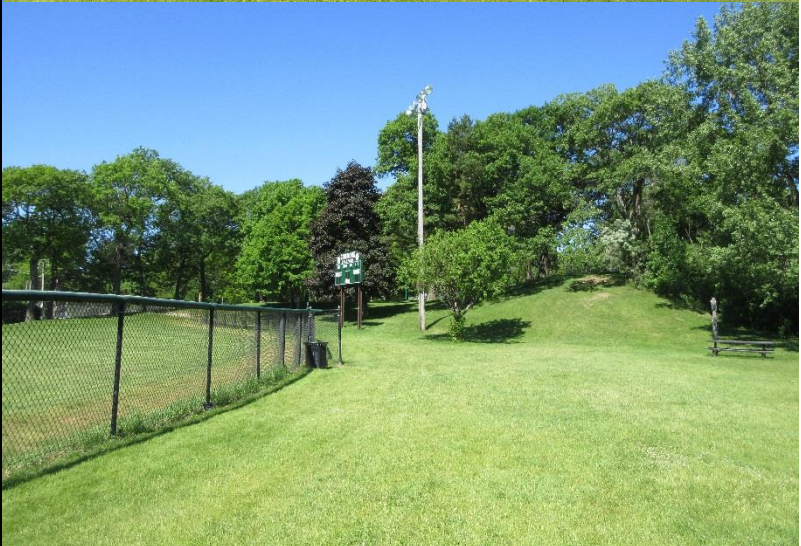
The Commons features four Knolls – two located to the northeast of the band shell, one located north of the ball field, and one in the northwest portion of the park where the bathhouse is currently located. The knolls are present in photographs and aerial images of the park throughout its history.

The knolls **ARE** Character Defining Features of Excelsior Commons.

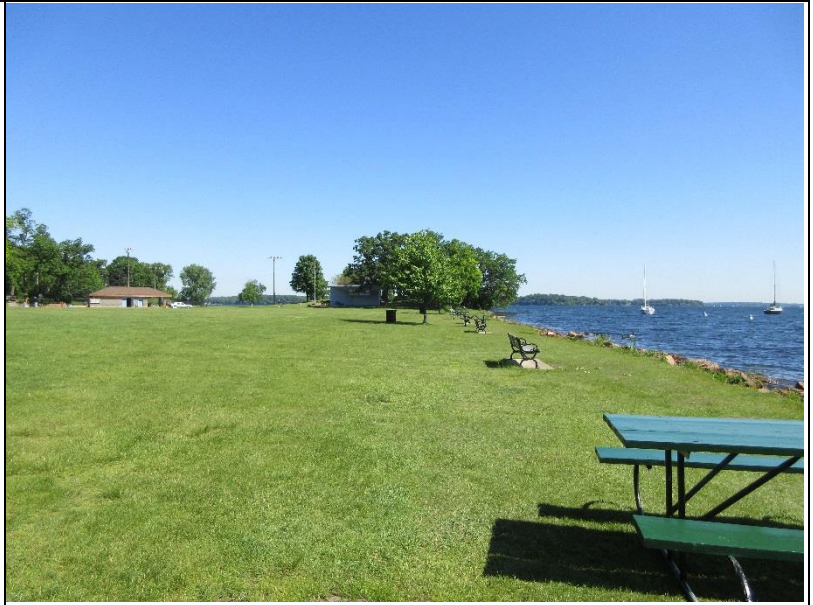
The expansive, relatively level lawn located to the north of the Port is present in historic photographs, aerial images and written descriptions of the park from throughout the Commons' history.

The Lawn **IS** a Character Defining Feature of Excelsior Commons.

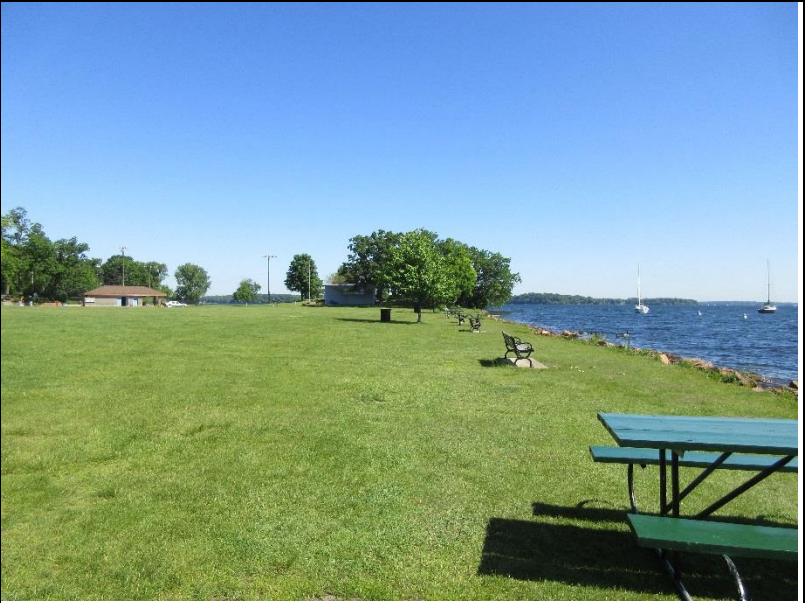
<p>Manicured Lawn</p> <p>The expansive, grass covered lawn located to the north of the Port is present in historic photographs, aerial images and written descriptions of the park from throughout the Commons' history.</p> <p>The manicured nature of the lawn IS a Character Defining Feature of Excelsior Commons.</p>

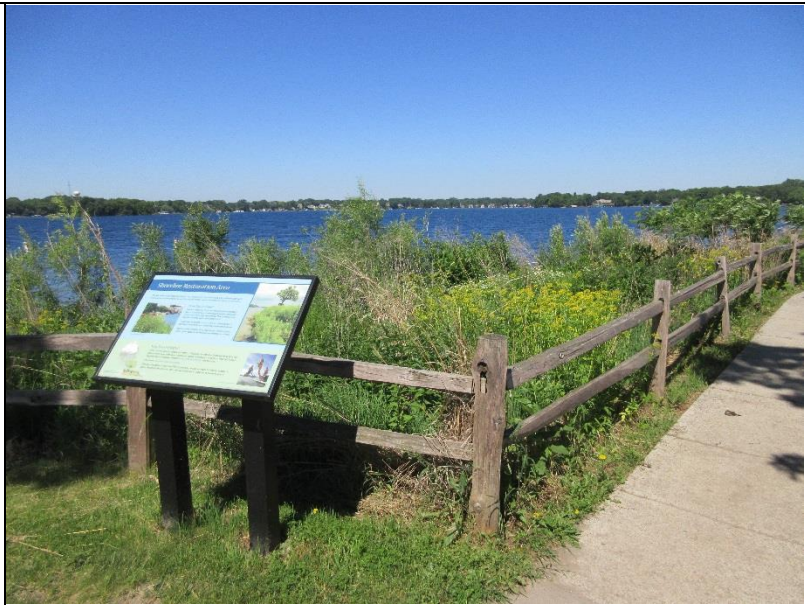
Restored Shoreline Planting

The restored shoreline planting near the bathing beach was installed in 2009.

The restored shoreline planting does not meet the 50 year rule and **IS NOT** a Character Defining Feature of Excelsior Commons.

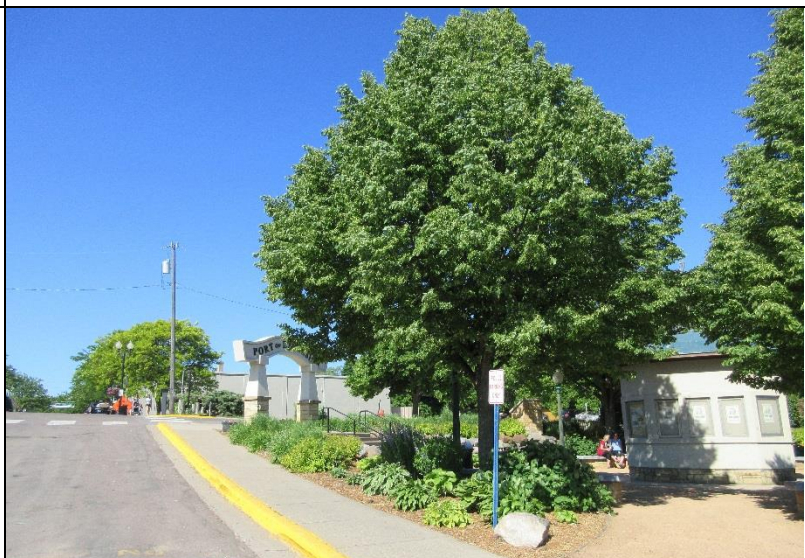
Composed Plantings

Composed planting beds are located throughout the Commons. In particular, beds are located near the Port entrance and ticket booth, the band shell, and in boxes next to some electrical equipment housings.

These composed plantings do not meet the 50 year rule and **ARE NOT** Character Defining Features of Excelsior Commons or the Port of Excelsior.

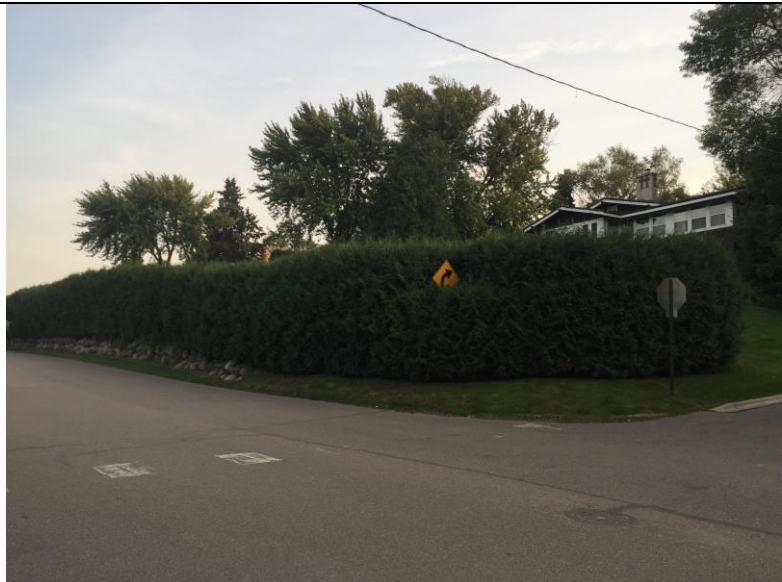
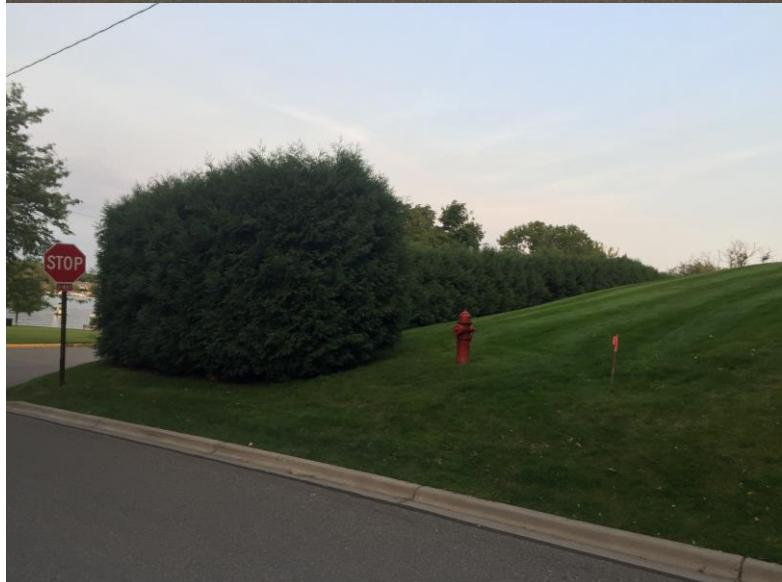
Hedge and Lawn West of Lake Street

An evergreen hedge is present at the “wedge” of Commons land west of Lake Street. The hedge extends from Courtland Street to a little over half way to Center Street. The remainder of the “wedge” property is a grassy lawn.

Historic aerial photos of the Commons suggest that the “wedge” has generally been lawn. Trees are present in some images. The hedge is not present in historic aerial images. The hedge **IS NOT** a Character Defining Feature of Excelsior Commons. Historic aerial images suggest that this area has always been lawn, it is likely that the presence of a lawn at this area **IS** a Character Defining Feature of Excelsior Commons.

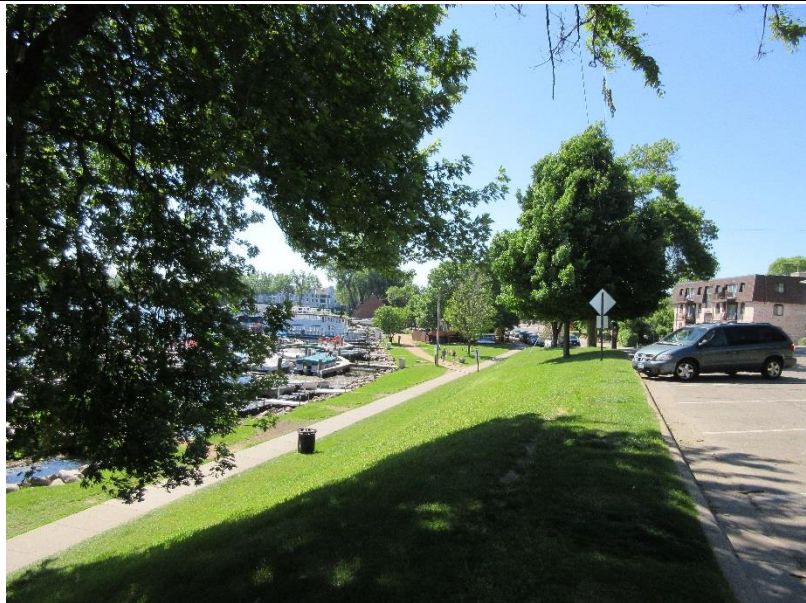
Path Parallel to Lake Street

A paved concrete walking path extends along the bottom of the Lake Street Slope generally parallel to Lake Street. Historic images and aerial photographs of the Commons suggest that a path has existed in this location since at least 1937.

The location of the path **IS** a Character Defining Feature of Excelsior Commons. The specific materials used to construct the path **ARE NOT** a Character Defining Feature of Excelsior Commons.

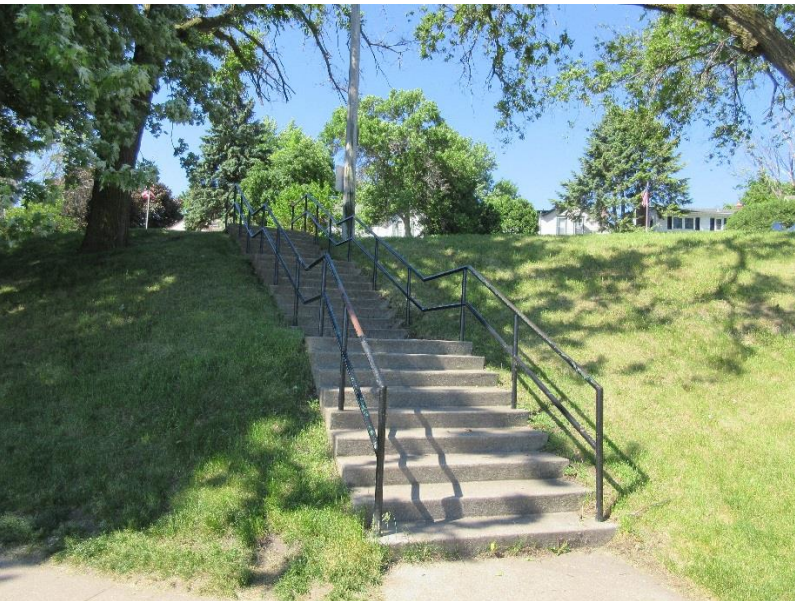
Vertical Connections At Lake Street Slope

Two sets of stairs provide vertical circulation along the Lake Street Slope. The stairs are concrete with metal hand rails. The date of installation of these stairs is unknown.

Historic images and aerial photographs of The Commons suggest that some type of vertical connections have existed at the Lake Street slope since the Period of Significance.

The two extant sets of stairs **ARE NOT** a Character Defining Feature of Excelsior Commons. The existence of vertical connections at the Lake Street slope **IS** a Character Defining Feature of Excelsior Commons.

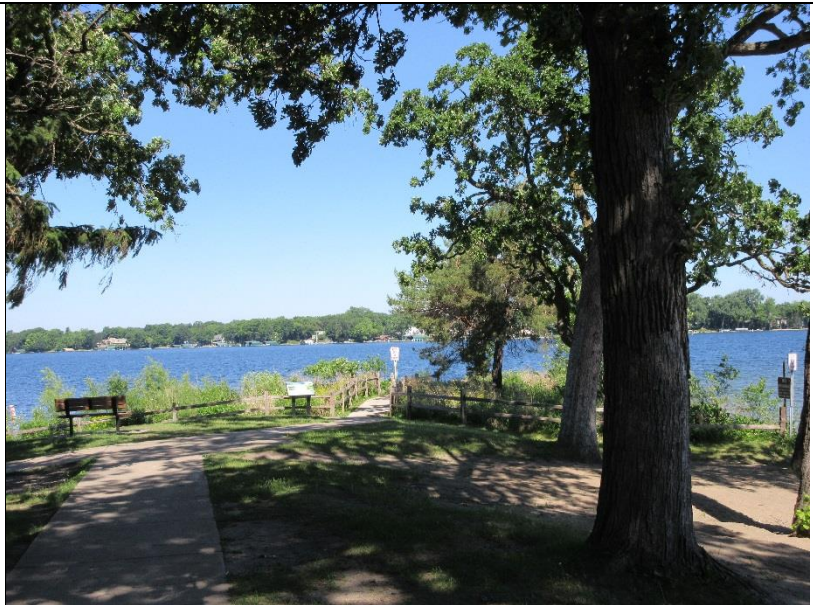
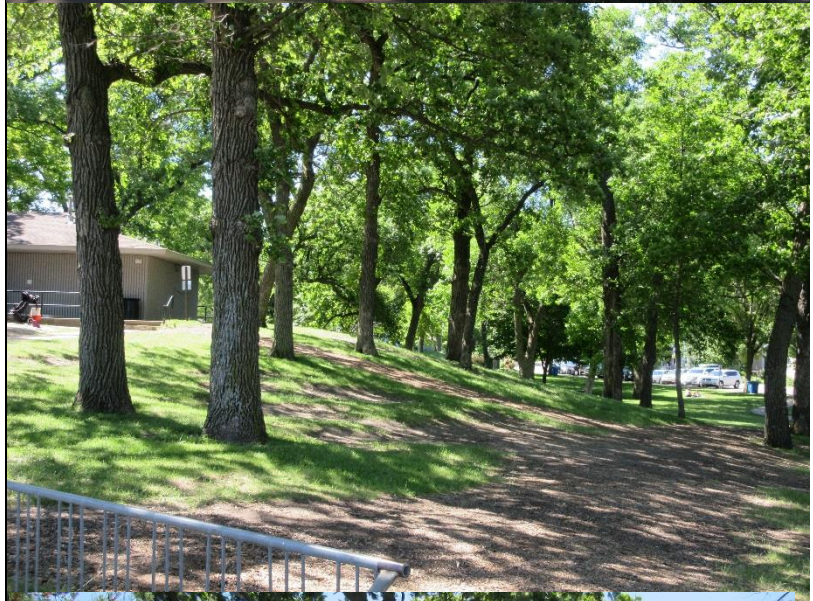
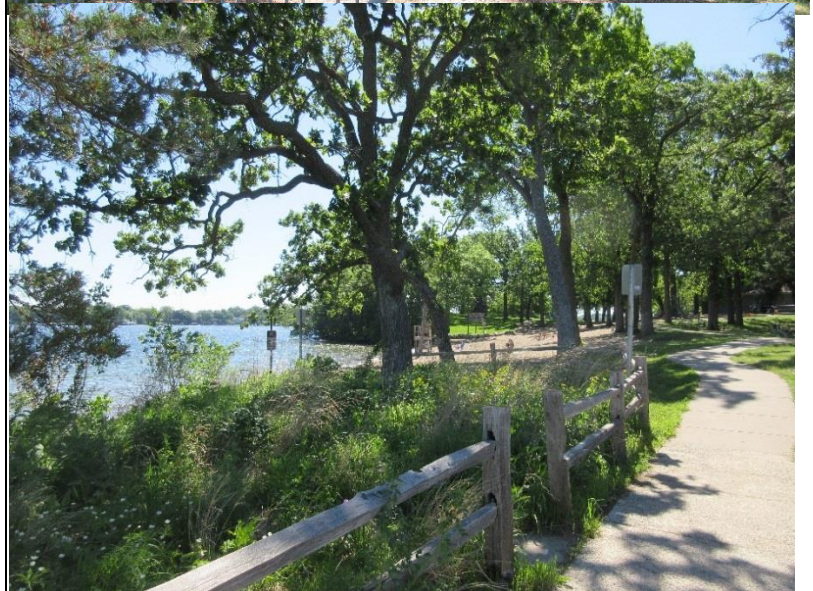
Paths Through the Northwest Portion of Park

Multiple gravel and concrete paths exist in the northwest portion of the park connecting the bathing beach, playground, bathhouse and northern knolls. Historic images and aerial photographs of the Commons do not provide any evidence that these paths follows historic circulation patterns.

The paths through the northwestern portion of the park **ARE NOT** Character Defining Features of Excelsior Commons.

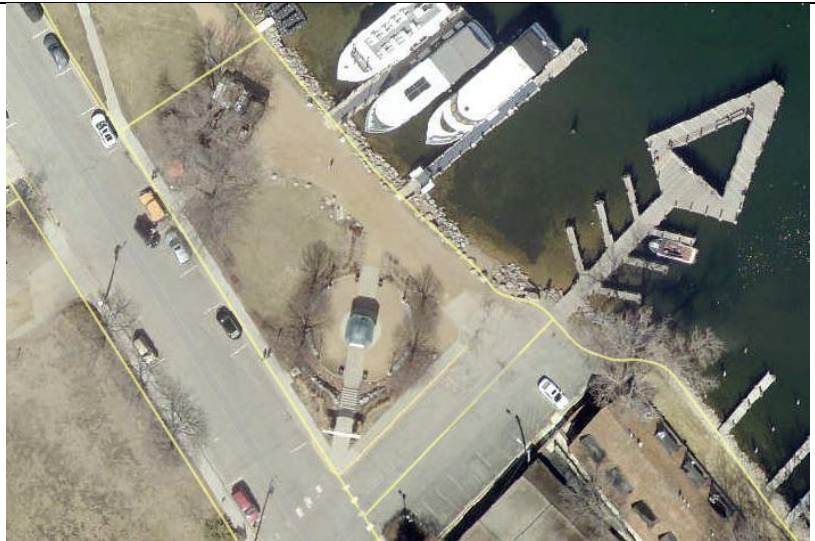
Aerial images dating to the period of significance for The Port show the presence of sidewalks along Water Street and Lake Street, however a path extending north from the corner of Water and Lake Streets is not legible.

The diagonal path **IS NOT** a Character Defining Feature of the Port of Excelsior.

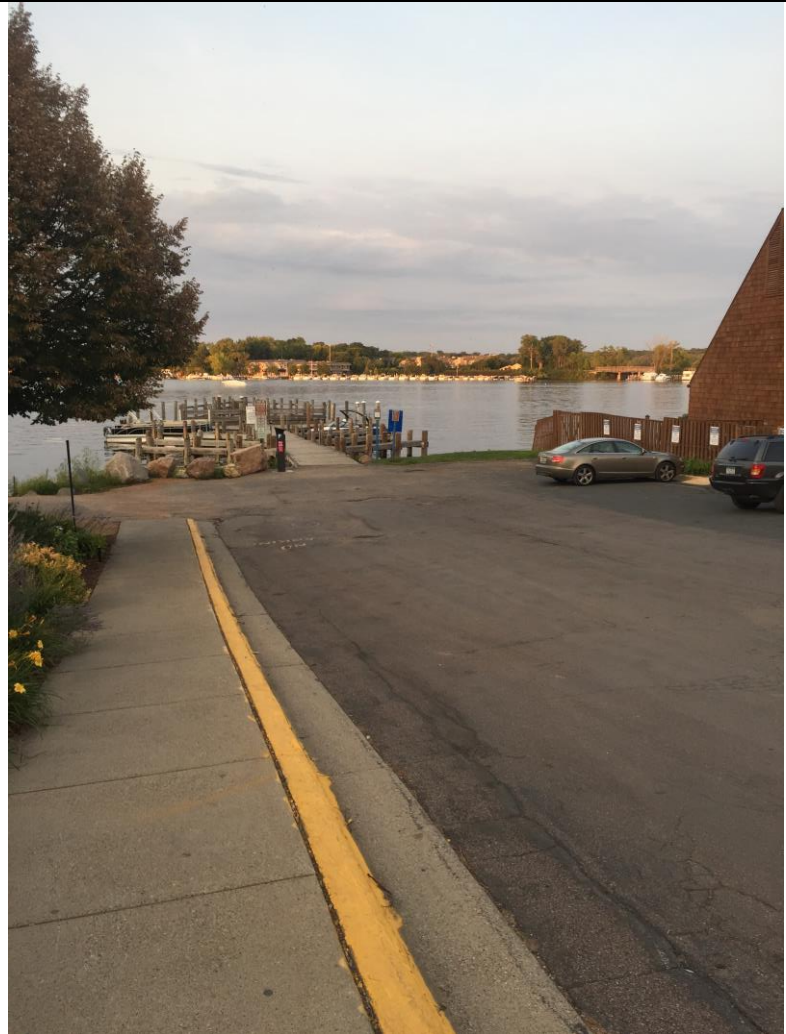
Evidence of access to Lake Minnetonka and The Port at Water Street is visible in historic aerial images dating back to 1937 (within the period of significance for the Excelsior Downtown Historic District). Aerial images also show that docks in various configurations were present at the terminus during the period of significance.

Circulation at the Water Street Terminus, including Lake and Port access and the existence of public docks **IS** a Character Defining Feature of the Port of Excelsior.

The terminus's existing docks and their configuration **ARE NOT** Character Defining Features of the Port of Excelsior.

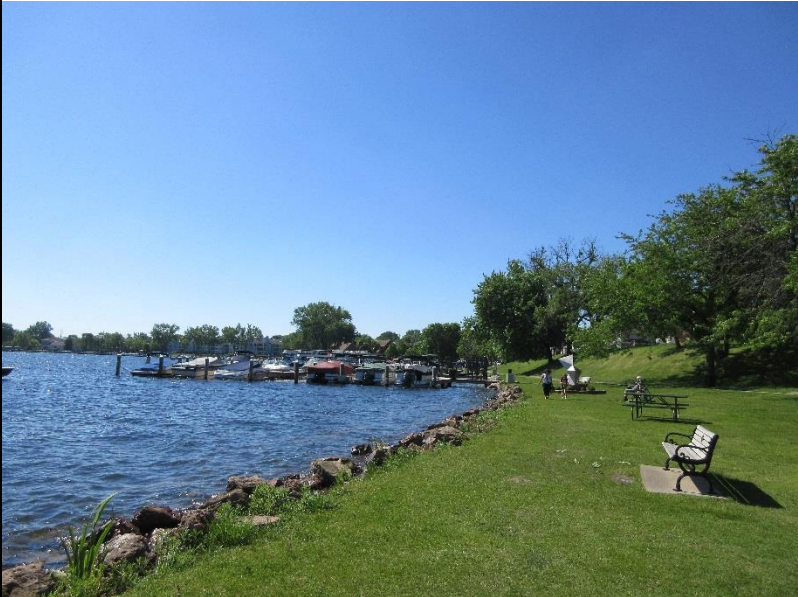
<p>Shoreline</p> <p>The current shoreline configuration was completed as part of the 1937 WPA work in The Commons (Appendix D). Riprap was installed along portions of the shoreline at this time.</p> <p>The overall alignment of the shoreline IS a Character Defining Feature of Excelsior Commons. Individual components of the riprap ARE NOT Character Defining Features of Excelsior Commons.</p> <p><i>Addressing the long-term environmental impacts of the existing shoreline treatment throughout the park is outside the scope of this report.</i></p>

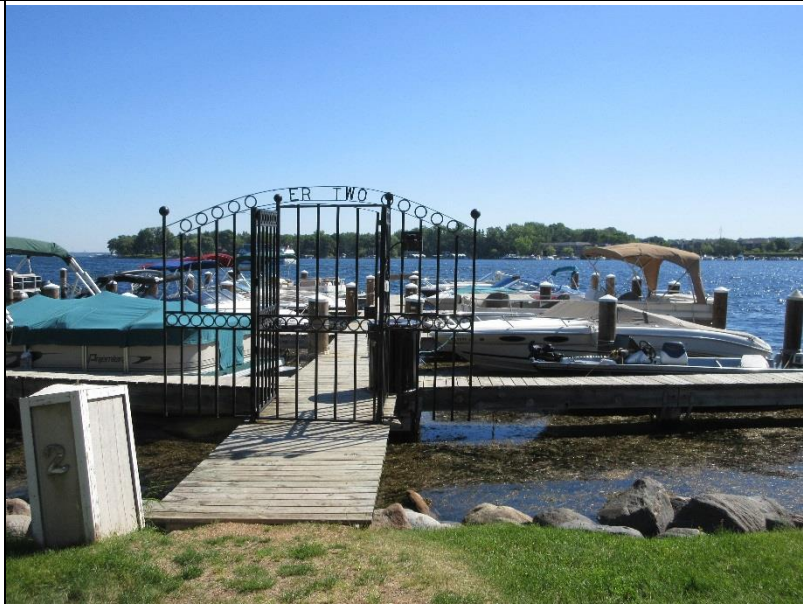
Historic images, and aerial photographs show that while docks have existed in this general location throughout the Commons' history, these specific docks post-date a 1976 site map (Appendix C) which shows that at that time The Commons and The Port had 10 dock structures whose locations do not align with the current 5 dock structures.

The existing docks and their gates do not meet the 50 year rule and **ARE NOT** Character Defining Features of Excelsior Commons or The Port of Excelsior.

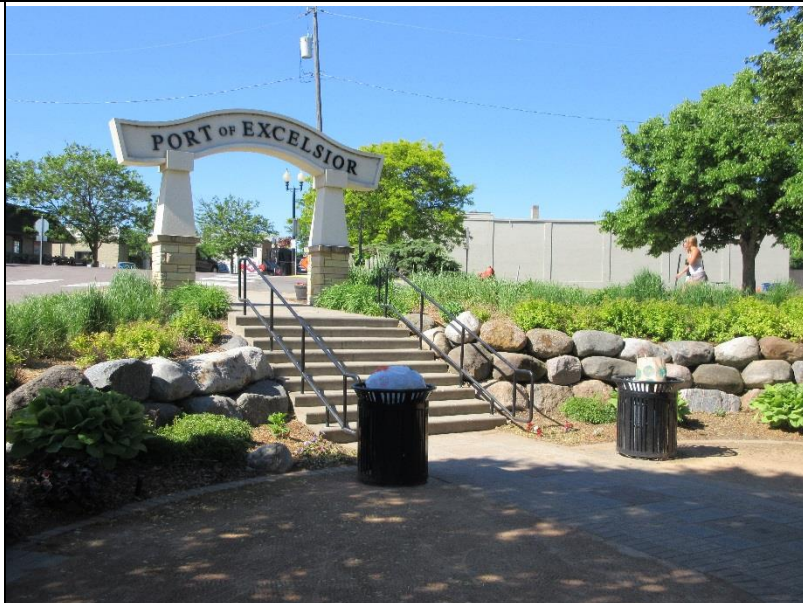
The entry plaza at the Port (including arch, stairs, paved plaza, plantings, and dedicated benches) was installed between 1996 and 1998.

The entry plaza in general does not meet the 50 year rule, and **IS NOT** a Character Defining Feature of the Port of Excelsior.

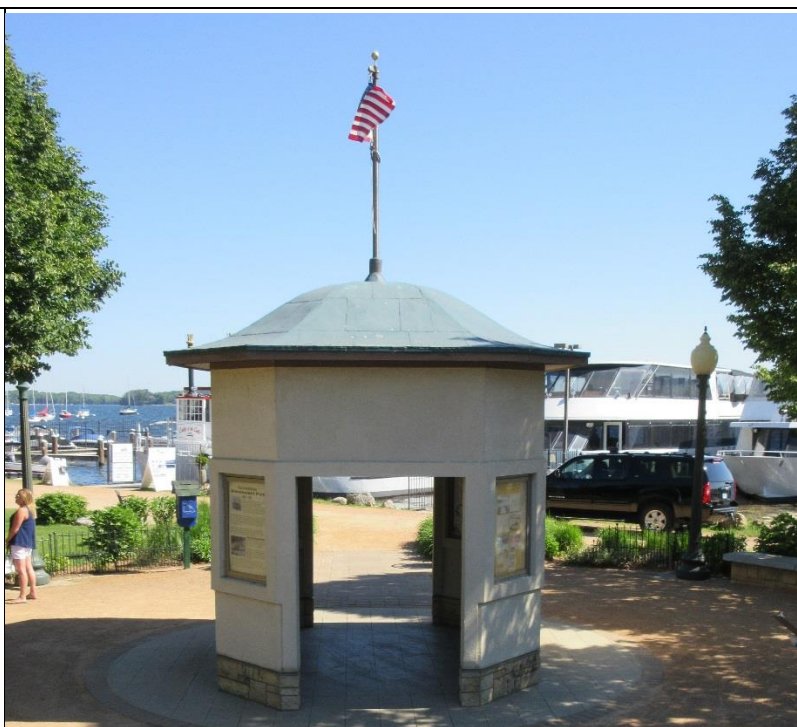
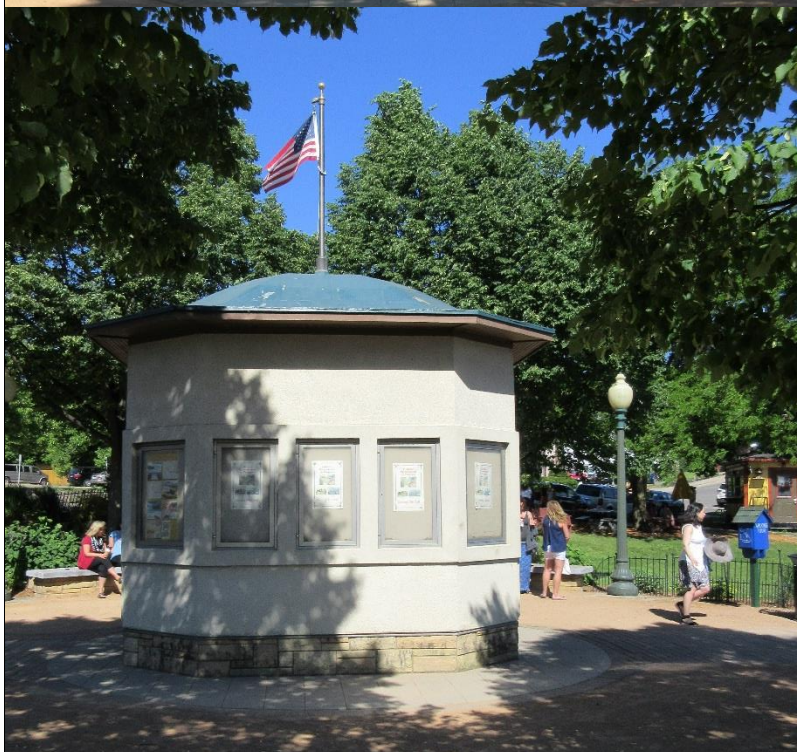
Blue Line Ticket Booth/Launch Livery

The original construction date of the Blue Line Ticket Booth is unknown – the structure is visible on Sanborn maps from 1911, though it may be older. Circa 1945, the ticket booth was removed from its original location in The Port of Excelsior and installed at the Excelsior Amusement Park. The ticket booth remained at the Amusement Park until 1973, and then was moved to a local resident's yard and later a storage facility before being reinstalled at The Port in 1997 (Excelsior Downtown Historic District Designation Study). In 1997, the ticket booth was replaced in a different location than the one it occupied during the Period of Significance for the Downtown Historic District.

Period of Significance for the District. However, the Ticket Booth is currently located in a different position than the one it occupied during the District's Period of Significance. If in the future the Ticket Booth is moved to yet another location within The Port, the move would not further damage the Ticket Booth's historic integrity.

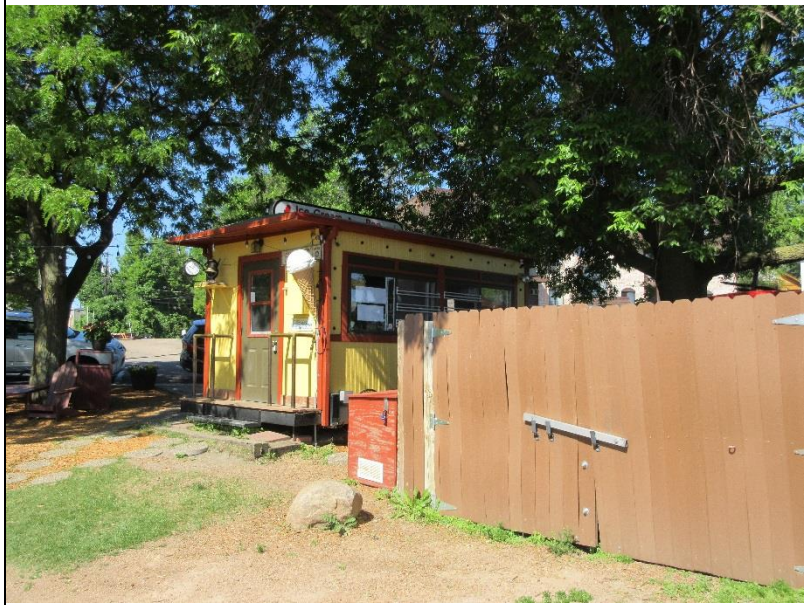
For-profit concessions located in the Port area have been a part of the Port and Commons throughout the park's history.

The current concession stand is mobile and can be removed from the park. The current concession stand does not meet the 50 year rule and **IS NOT** a Character Defining Feature of Excelsior Commons or the Port of Excelsior.

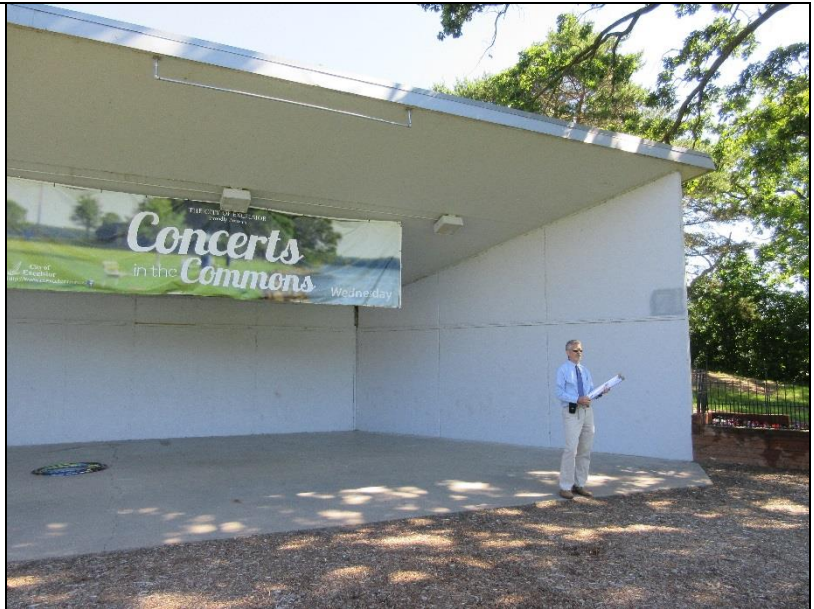
Band Shell

The band shell **may achieve historic significance** as part of Excelsior Commons or as an individual structure and is recommended for re-evaluation when it reaches 50 years of age.

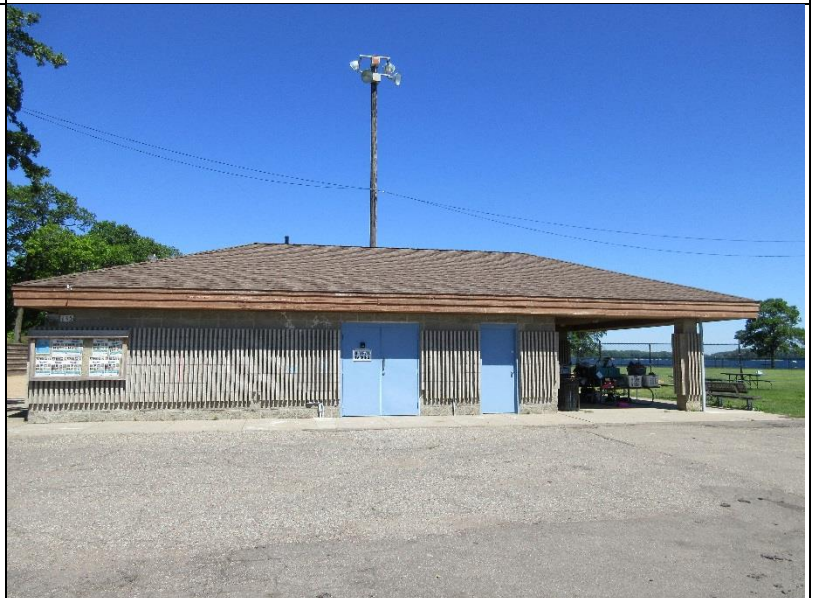
The concession stand building was constructed in 1987. (Today, the building is commonly known as the concession stand building – at the time of its design and construction, the building was referred to as the maintenance building.) The building has concrete walls and a hipped roof with asphalt shingles. The building is utilitarian in nature and does not exhibit exceptional architectural design.

The building does not meet the 50 year rule, and **IS NOT** a Character Defining Feature of Excelsior Commons.

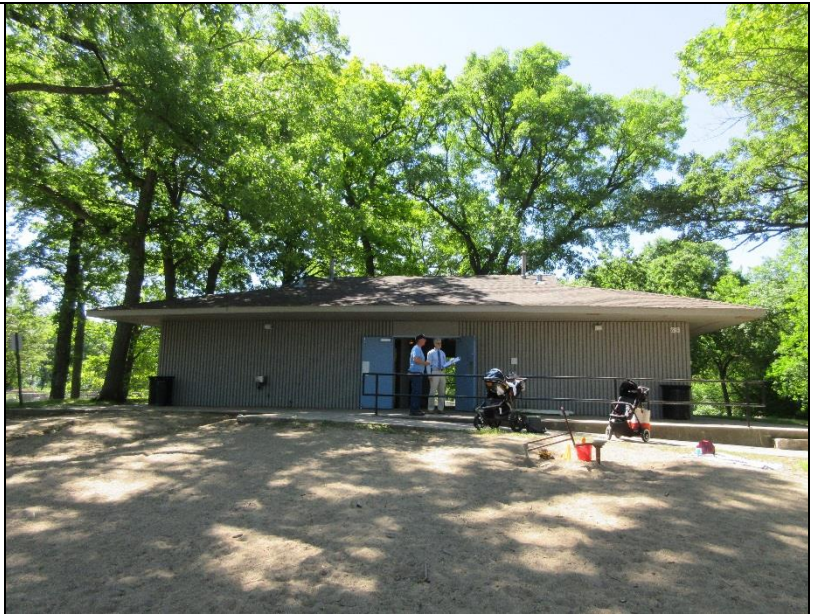
The current bathhouse was constructed in 1968, replacing multiple earlier iterations of bathhouses located within the park. The building has concrete walls and a hipped roof with asphalt shingles. The building is utilitarian in nature and does not exhibit exceptional architectural design.

The building does not meet the 50 year rule, and **IS NOT** a Character Defining Feature of Excelsior Commons.

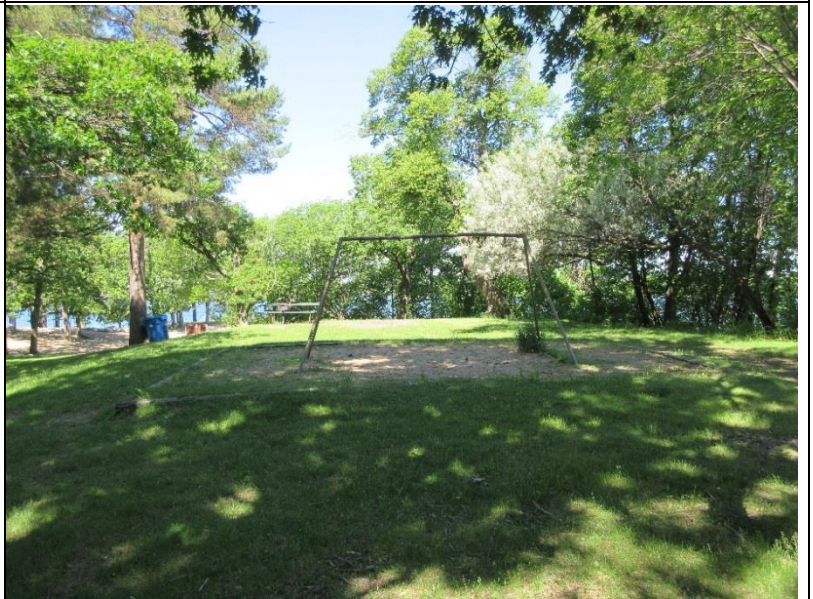
The remnants of a swing set are located between the western knoll and the bathhouse. Historic images and site maps show that the swing set dates to at least 1976.

The swing set does not retain historic integrity and does not meet the 50 year rule. The swing set **IS NOT** a Character Defining Feature of Excelsior Commons.

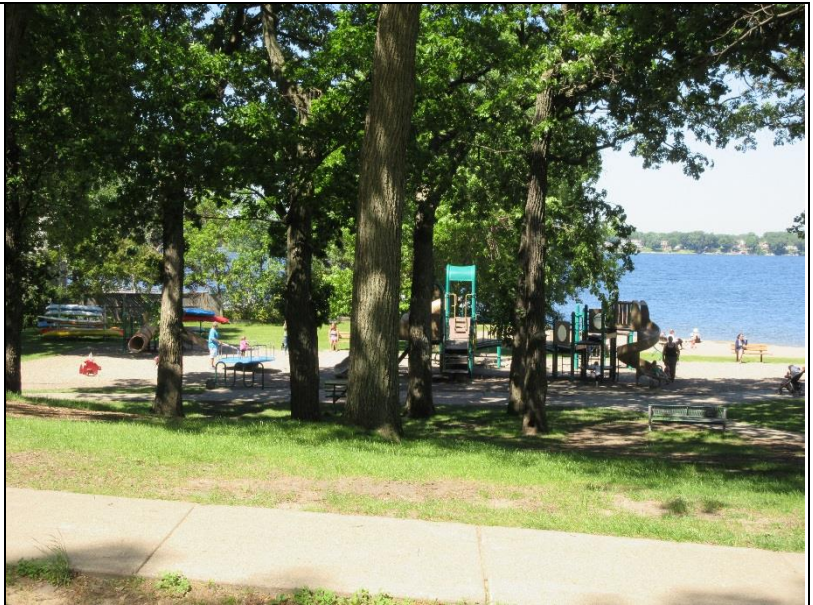
Playground equipment is located at the northern edge of the park and adjacent to the bathhouse. City records indicated that existing playground equipment was originally installed in 1994, with components upgraded over time as use and safety regulations require.

The playground equipment does not meet the 50 year rule, and **IS NOT** a Character Defining Feature of Excelsior Commons.

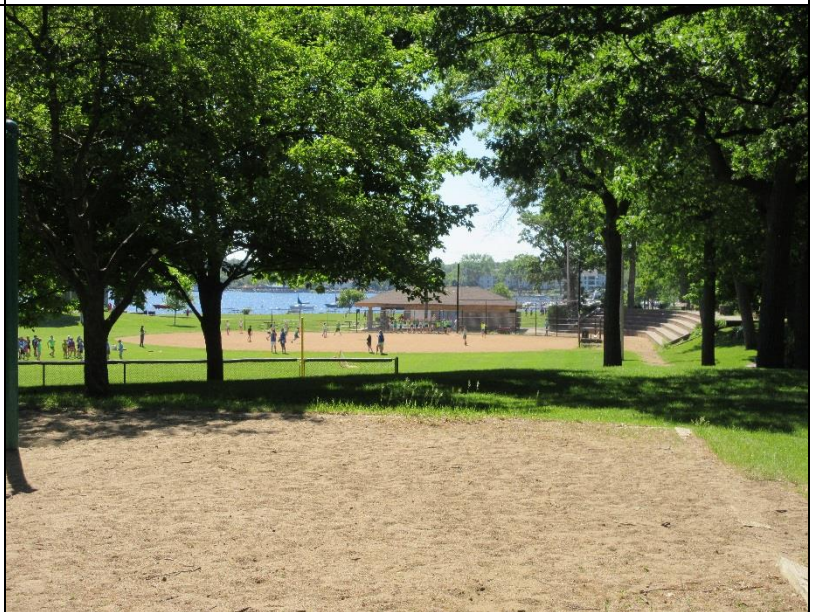
Historic photographs, aerial images, and written documentation confirm that a ball field has been located in the same general location within the Commons since the 1920s.

The general location of the baseball field **IS** a Character Defining Feature of Excelsior Commons.

The specific materials used to construct the current baseball field - i.e. sand, grass, metal fencing - **ARE NOT** Character Defining Features of Excelsior Commons.

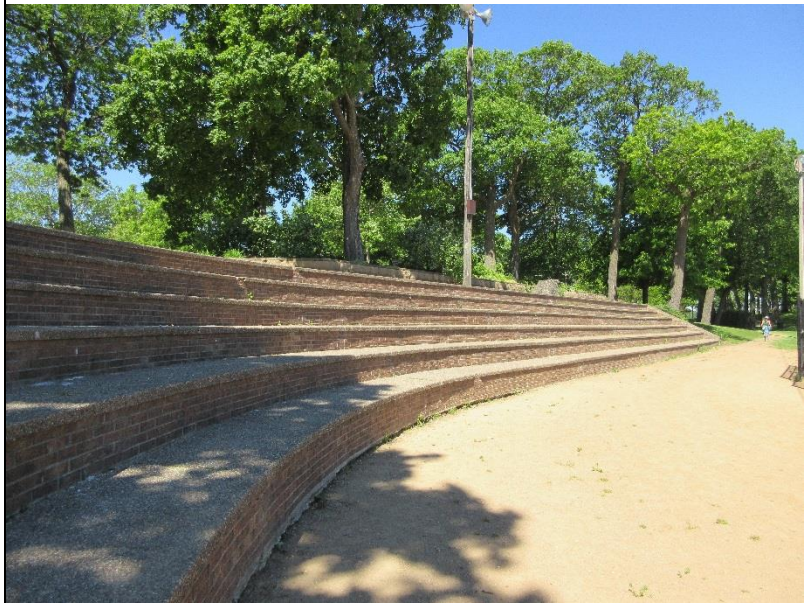
Baseball Field Seating

The baseball field seating was installed in 1937 by the WPA – the seating retains its original location, shape (design), and setting. Additionally, the seating continues to feel like WPA-era construction, and to be easily identifiable as seating for the baseball field (association). Modern finish materials have been installed over or replaced the original stone construction.

The baseball field seating retains integrity, and **IS** a Character Defining Feature of Excelsior Commons.

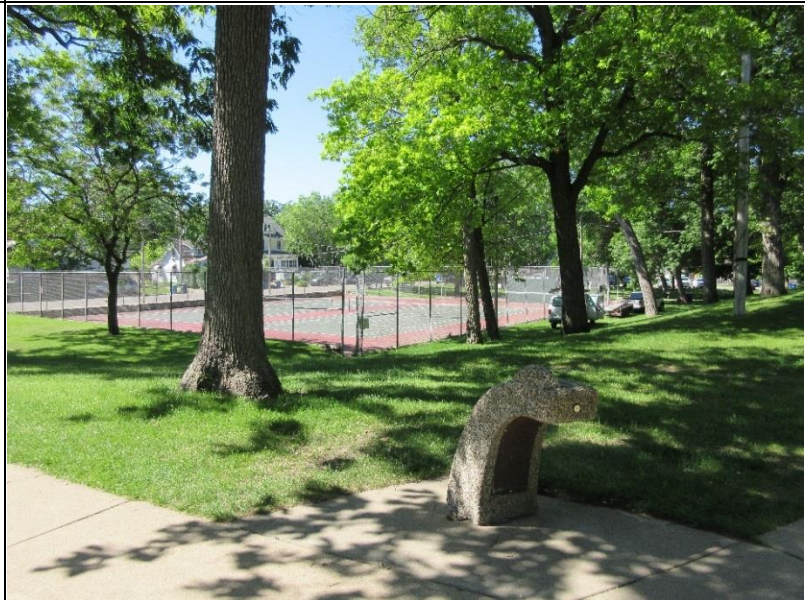
Historic documentation places the construction of the tennis and basketball courts between 1962 and 1971.

The tennis and basketball courts was not present in 1937 and may not meet the 50 year rule. The tennis and basketball courts **ARE NOT** Character Defining Features of Excelsior Commons.

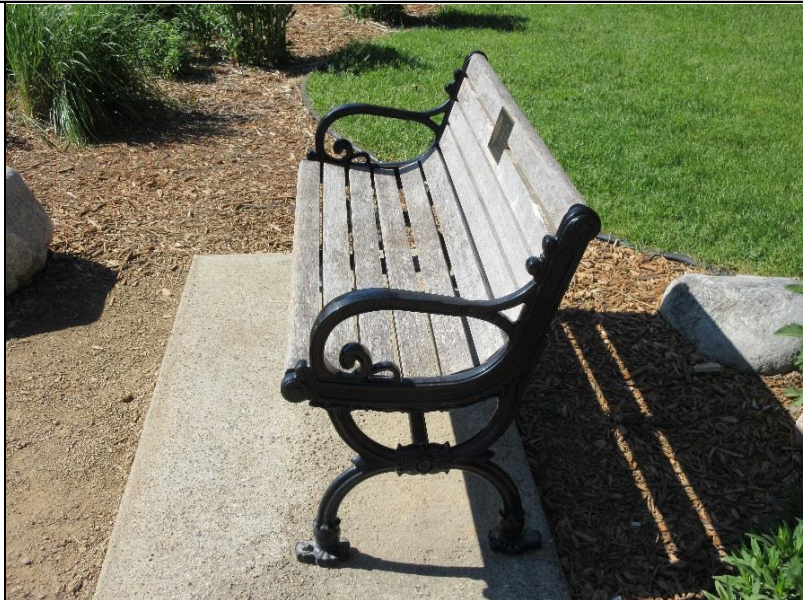
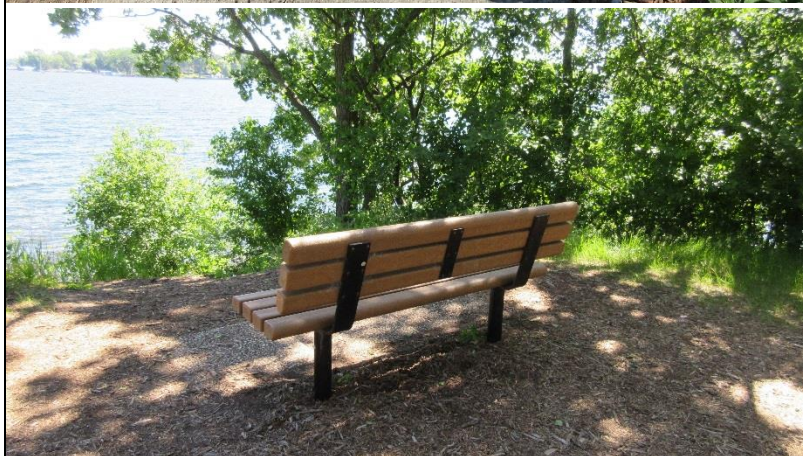
The benches are generally constructed of metal and wood. Some exhibit dedication plaques.

The benches do not meet the 50 year rule and **ARE NOT** Character Defining Features of Excelsior Commons or the Port of Excelsior.

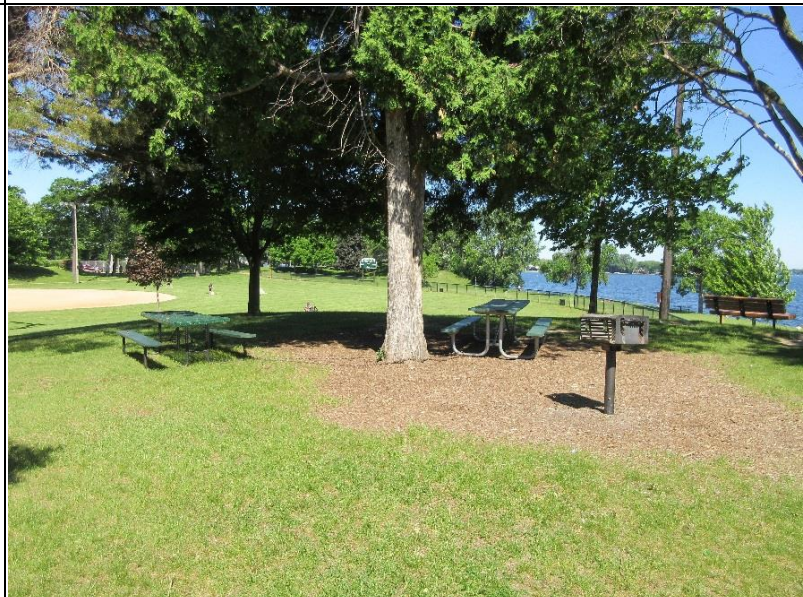
5 grills are located throughout the Commons. According to city records, the grills date to 2012.

The grills located throughout the park are not permanent structures, do not meet the 50 year rule, and **ARE NOT** Character Defining Features of Excelsior Commons.

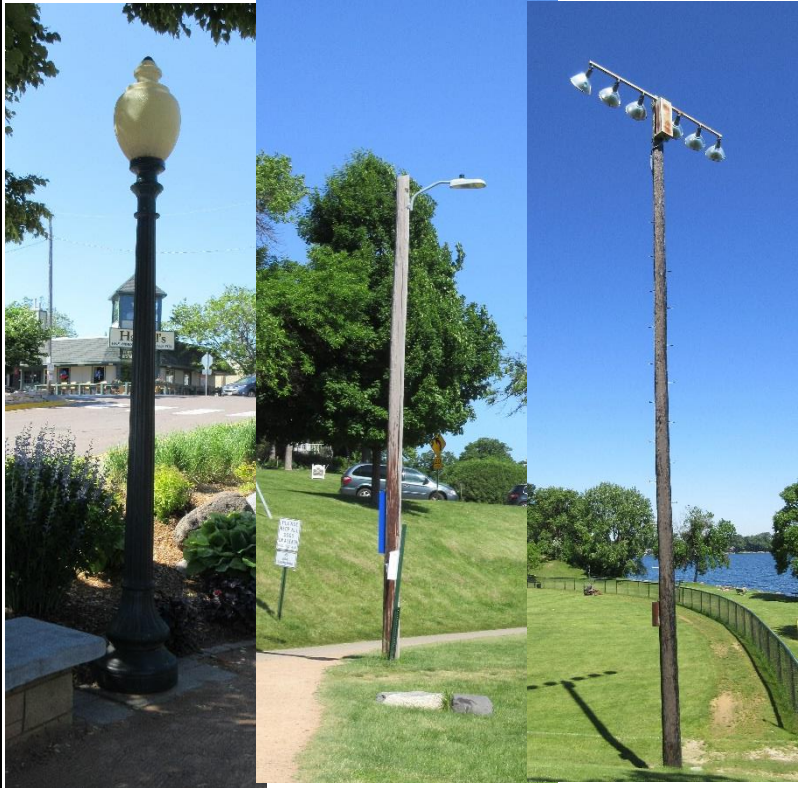
Light fixtures located throughout the park appear to be modern installations and do not exhibit a standard design language.

Light fixtures located throughout the park likely do not meet the 50 year rule. Light fixtures located within the park **ARE NOT** Character Defining Features of Excelsior Commons or the Port of Excelsior.

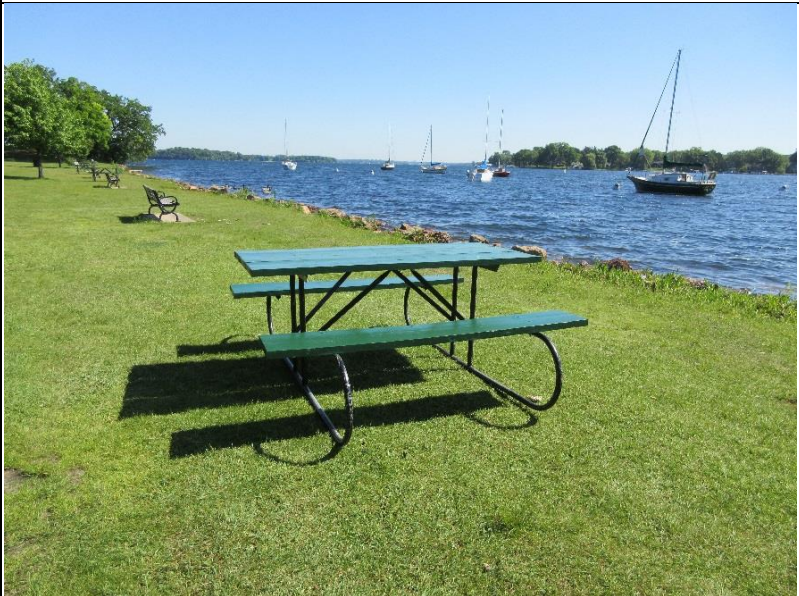
According to city records, the park's 29 picnic tables were installed between 1987 and 2008. The picnic tables are generally constructed of metal and painted wood.

The picnic tables located throughout the park are not permanent structures, do not meet the 50 year rule, and **ARE NOT** Character Defining Features of Excelsior Commons or the Port of Excelsior.

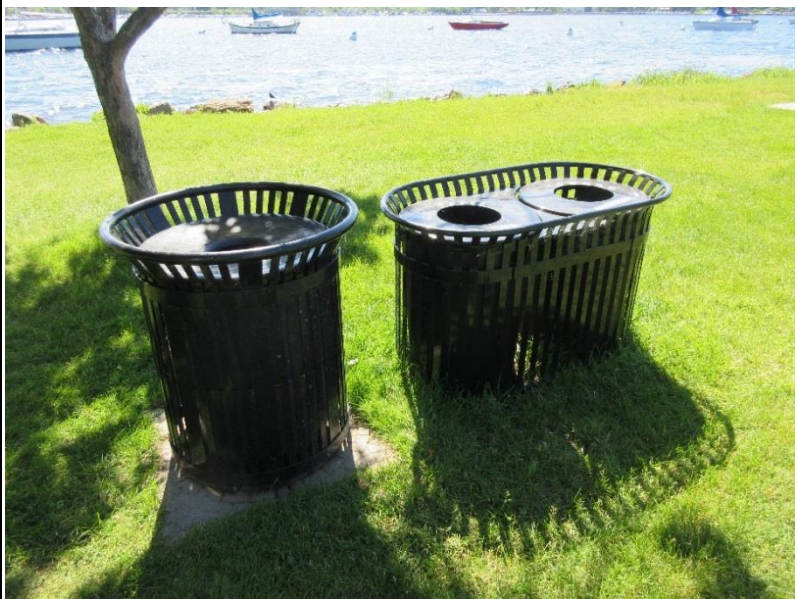
According to city records, the park's 25 single-opening garbage receptacles were installed in 2011 and the 4 double-opening garbage/recycling receptacles were installed in 2015.

The garbage/recycling receptacles found throughout the park are not permanent structures, do not meet the 50 year rule, and **ARE NOT** Character Defining Features of Excelsior Commons or the Port of Excelsior.
