Site Inventory and Period of Significance Study

Excelsior Commons and Port of Excelsior
Excelsior, Minnesota

November 3, 2017

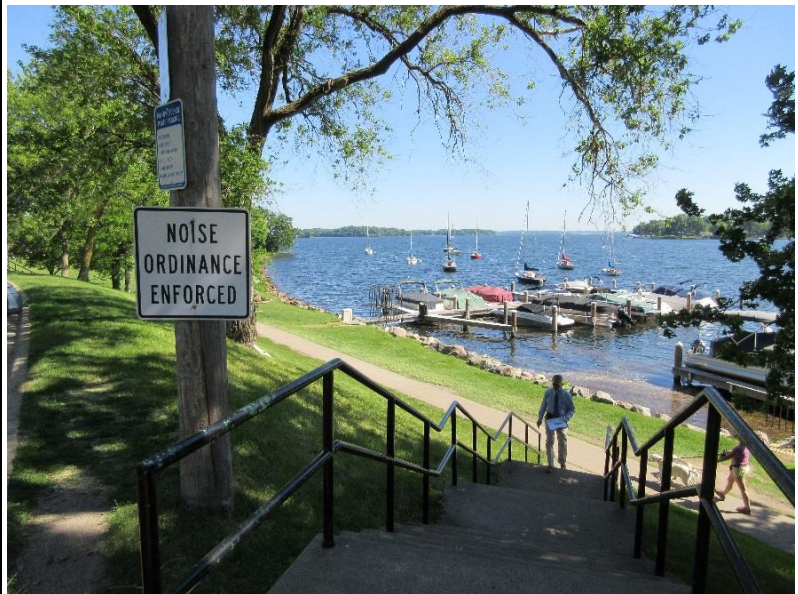
The typical modern city-provided signage is located throughout the park.

Signage does not meet the 50 year rule and **IS NOT** a Character Defining Feature of Excelsior Commons or the Port of Excelsior.

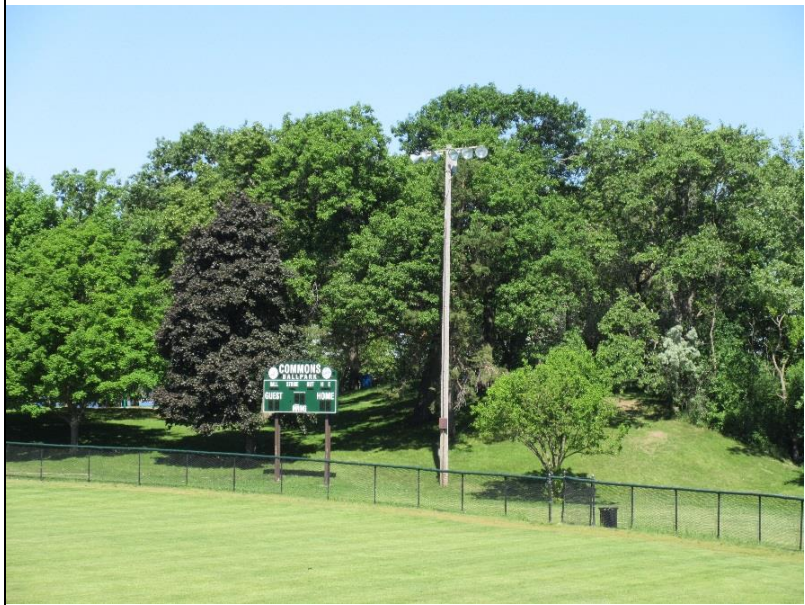
An electric score board is located next to the baseball field. The score board was installed in 2017.

The baseball field score board does not meet the 50 year rule and **IS NOT** a Character Defining Feature of Excelsior Commons.

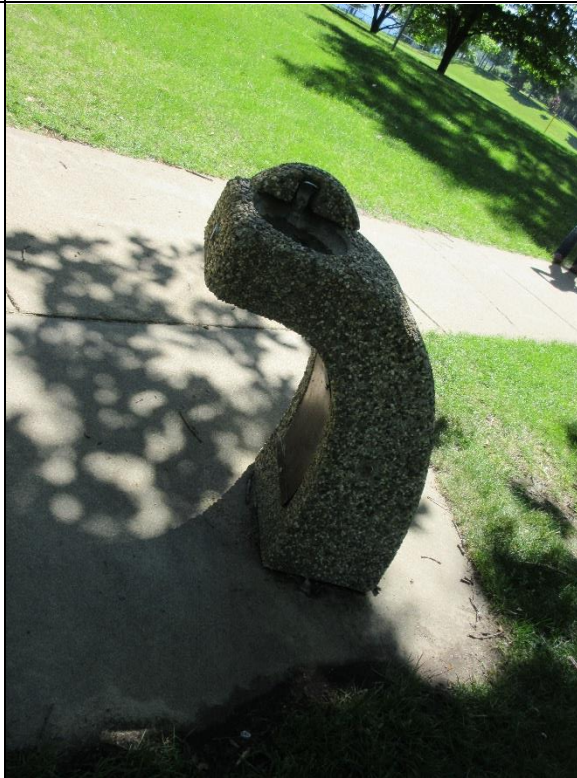
A single water fountain is located within the park near the tennis and basketball courts. The installation date of the water fountain is not known.

The water fountain **IS NOT** a Character Defining Feature of Excelsior Commons.

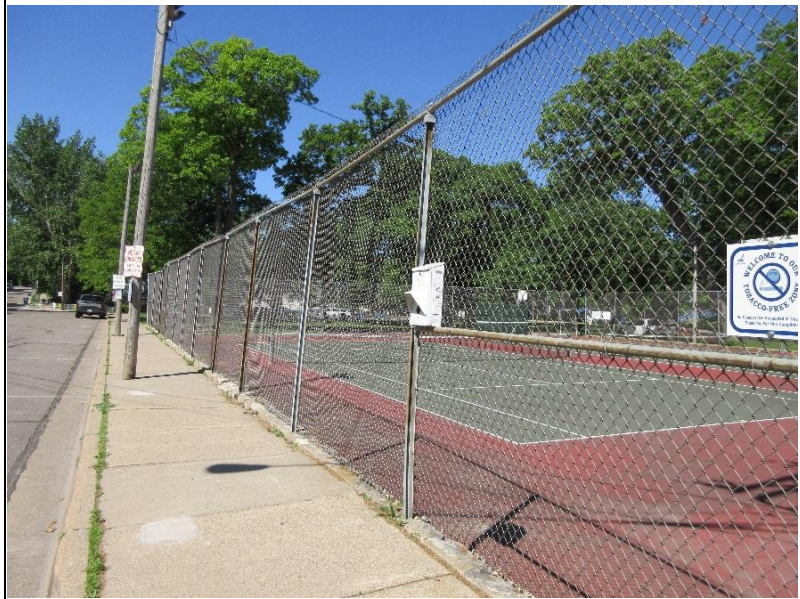
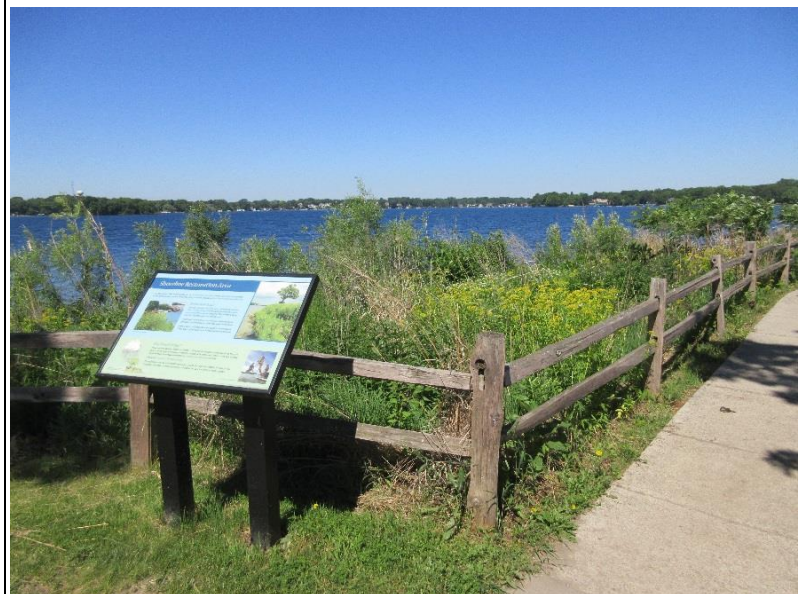
Metal and wood fencing is located throughout the park – surrounding the tennis and basketball courts, baseball field, and restored prairie among other locations.

The various fences found throughout the park **ARE NOT** Character Defining Features of Excelsior Commons.

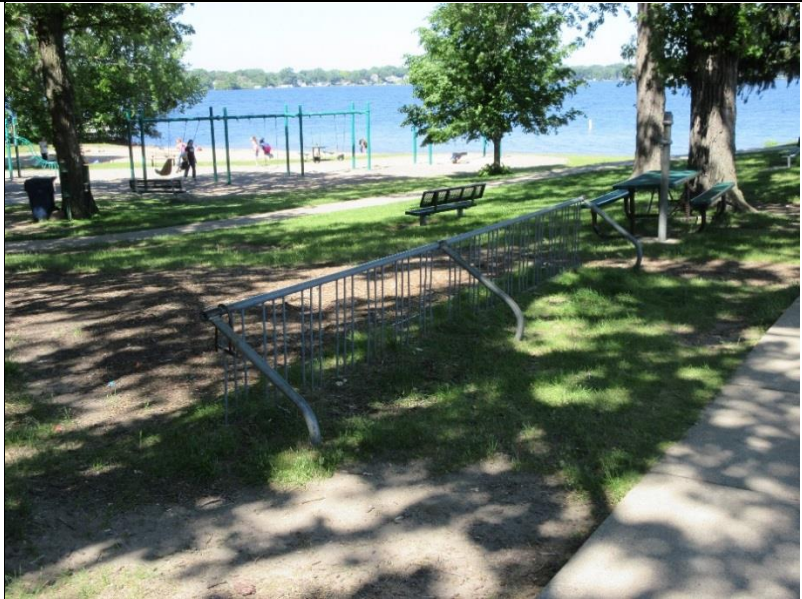
A single metal bike rack is located between the bath house and play ground. Historic photographs and site maps confirm that the bike rack has existed since at least 1976.

The bike rack **IS NOT** Character Defining Features of Excelsior Commons.

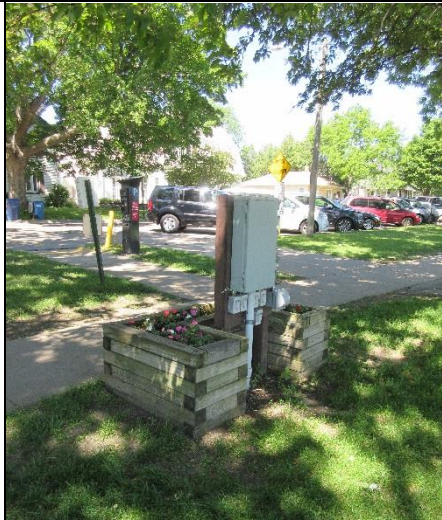
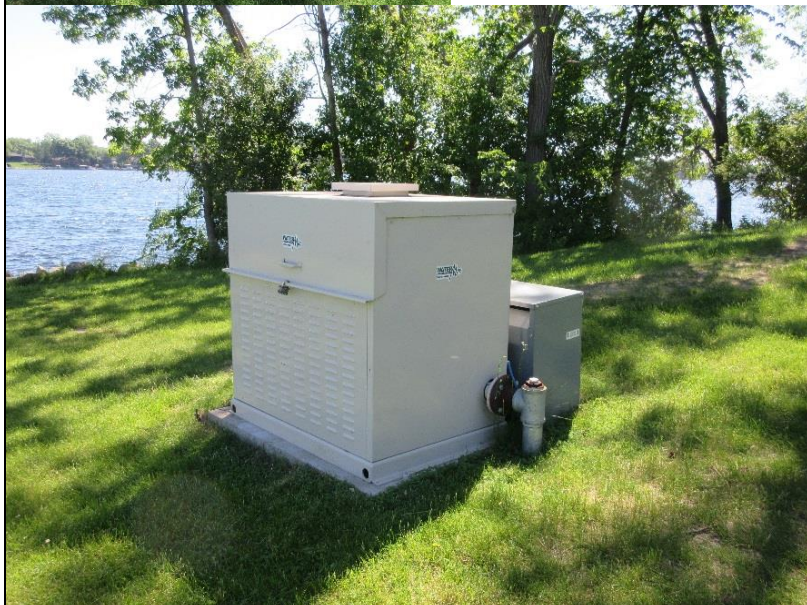
Electrical Equipment

Electrical equipment (boxes, transformers, panels, etc.) is located throughout the park. These housings are utilitarian in nature, and were not specially designed to integrate with the park environment. It is unlikely that they meet the 50 year rule.

The electrical equipment found throughout the park **IS NOT** a Character Defining Feature of Excelsior Commons or the Port of Excelsior.

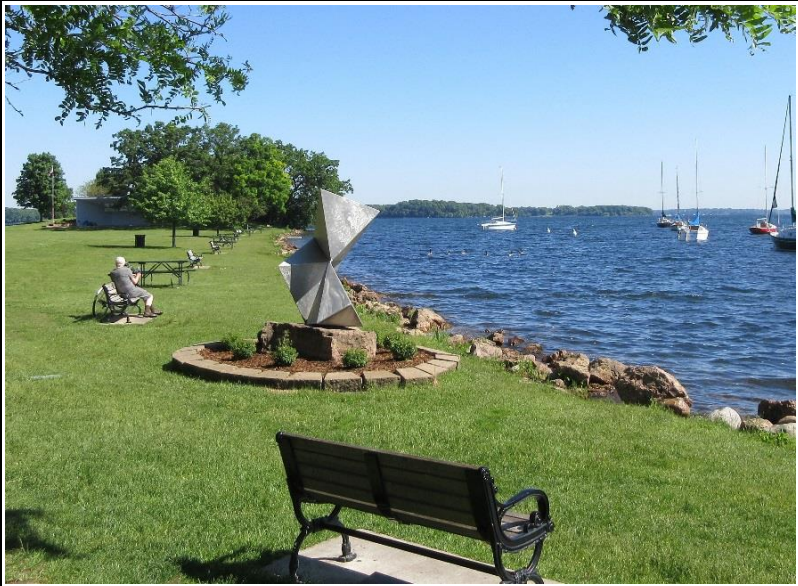
“Sails”

The Sails sculpture, created by local artist Katherine Nash, was installed in the Commons in 1980.

Sails does not meet the 50 year rule and **IS NOT** a Character Defining Feature of Excelsior Commons.

Recommendation to re-evaluate in future.

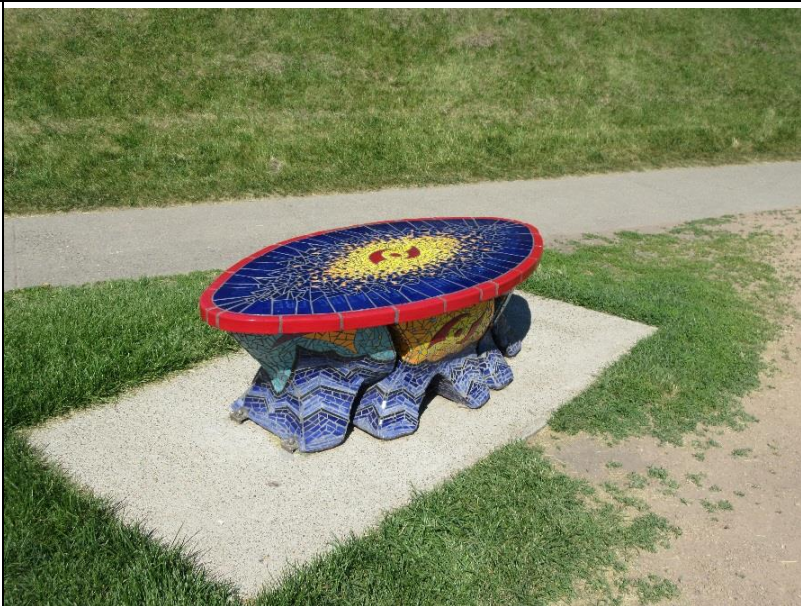
“Debbie’s Bench”

Mosaic bench/sculpture designed by local artist David Cooley, and installed in 2014.

This bench/sculpture does not meet the 50 year rule and **IS NOT** a Character Defining Feature of Excelsior Commons.

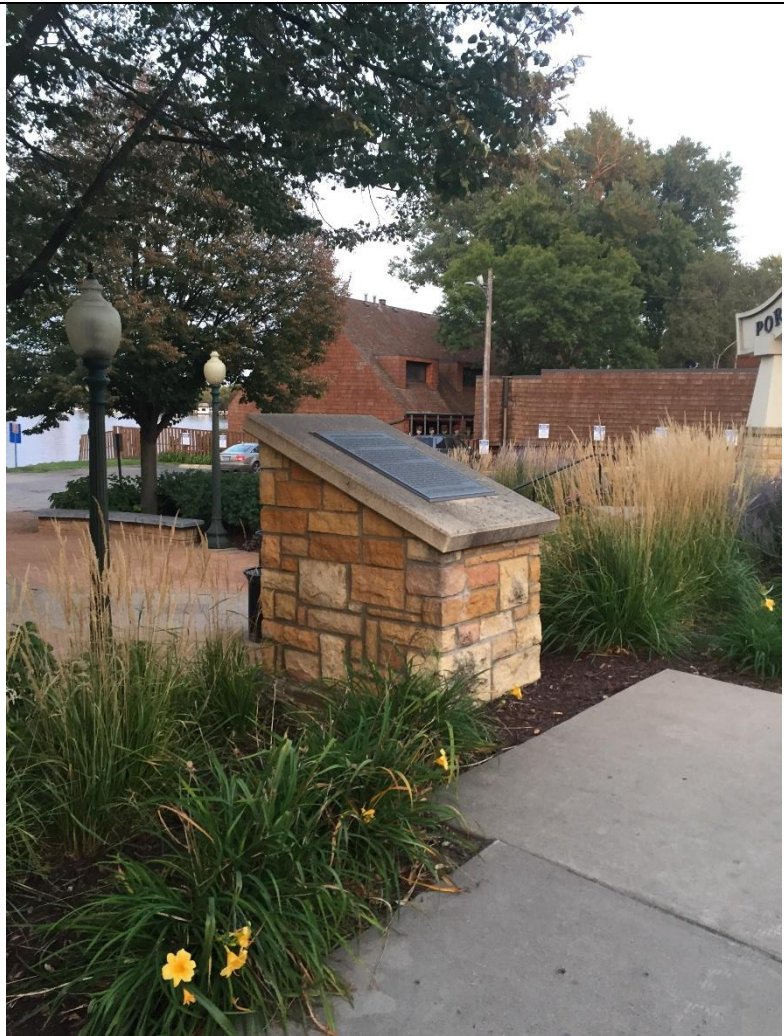
Geological Marker

A geological marker is present to the west of the Port of Excelsior Entry Plaza and adjacent to the public sidewalk along Lake Street.

The geological marker originally dates from 1953, and was first located at the MNDOT right of way along Highway 7. In 1998, the marker was relocated to its current location by Excelsior residents and business owners. The marker is owned by the Minnesota Historical Society.

The marker does not meet the 50 year rule and **IS NOT** a Character Defining Feature of the Port of Excelsior.

Following their review of a draft of this report, the Excelsior Heritage Preservation Commission has requested it be noted that while the marker does not meet the criteria to be a Character Defining Feature of The Port, the marker does contain important and relevant historical information and should be retained in the Port area.
